## **Determining the Cause of Faults in the SAE 1018 Carbon Steel Used in Potable Water Pipelines by Means of Digital Image Processing**

In this work the reason of the cracks found in SAE 1018 carbon steel pipelines used for potable water supply is determined. In order to accomplish it, some techniques of microanalysis using X-rays (SEM: Scanning Electron Microscopy) over some samples of faulty and normal pipes as well as the Digital Image Processing (DIP) of its microphotographs captured by means of SEM, were used. The obtained results prove that the low quality of the raw material and the steel manufacturing process were the reason of the cracks observed in the SAE 1018 carbon steel pipelines.

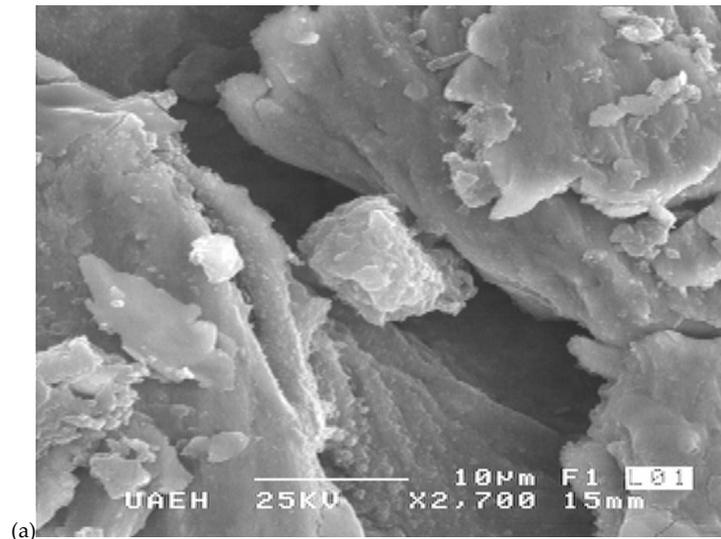
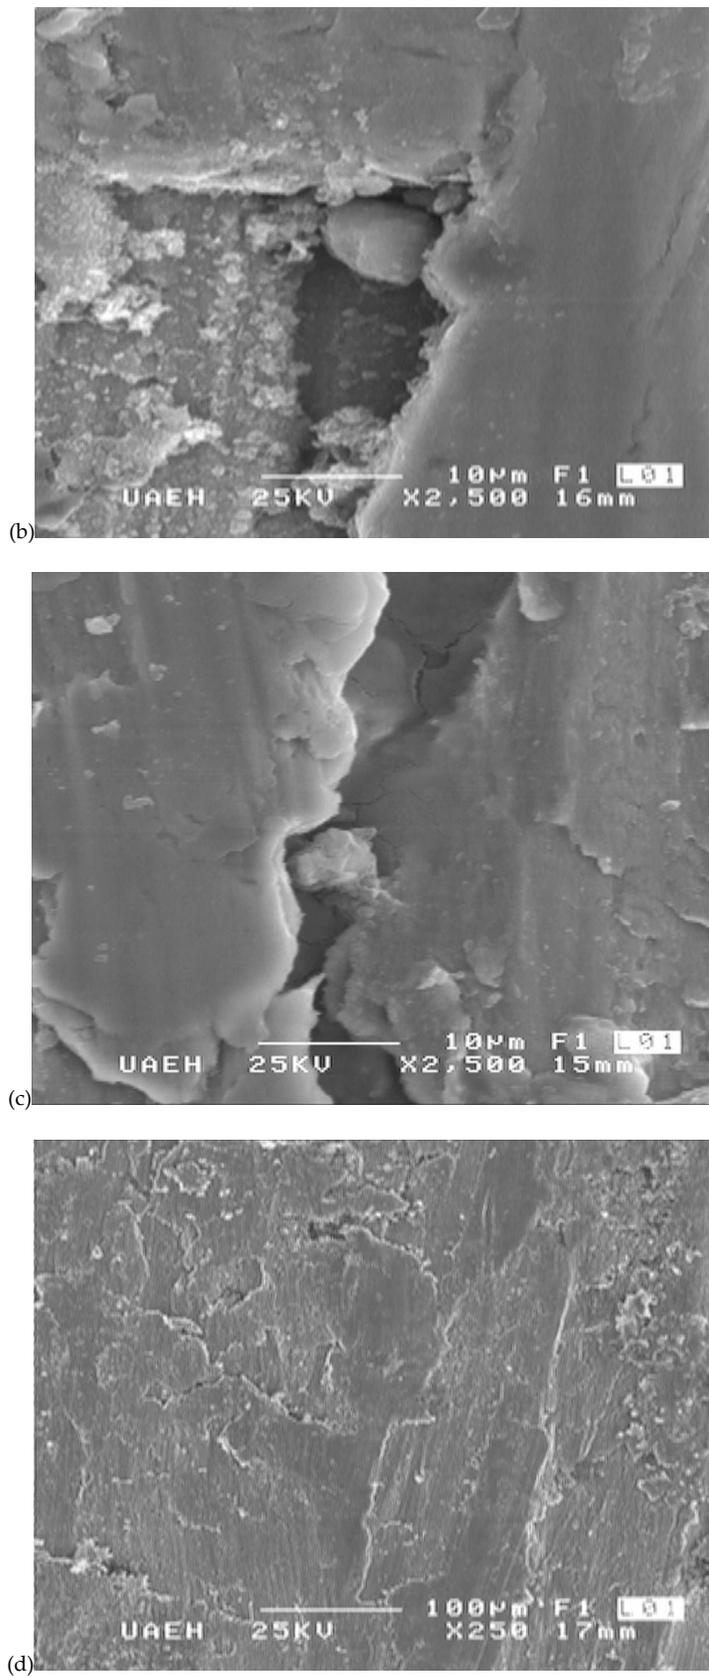
Figure 1. (a) (b) (c) Microphotographs, taken by SEM, of three samples from inside the SAE 1018 carbon steel pipes with damage; d) Idem for a non-damaged sample.

The analysis of images (a), (b) and (c) in Figure 1 captured from the faulty samples, and of image (d) obtained from the normal sample, is accomplished employing a thresholding procedure to extract (to segment) the image's lightest regions that indicate silicon presence, for the purpose of quantifying the percent of the area occupied by this element, regarding the whole sample area.(10) If the image contains no silicon signs, then the segmented area will be practically equal to zero, as shown in Figure 1(d).

Since by several factors the silicon inclusions can appear along time in a random way, inclusion may occur at several levels overlapped among themselves, as observed in Figures 1(a), 1(b) and 1(c).
