Publicación anual, Vol. 8, No. 8 (2021) 25-29

Análisis de falla en propela de admisión en turbocargador de auto Failure analysis of propeller shaft in automotive turbocharger

M. Flores-Baez⁽¹⁰⁾, I. Flores-Baez⁽¹⁰⁾, P. Vera-Serna⁽¹⁰⁾*, R. Palomino-Resendiz⁽¹⁰⁾

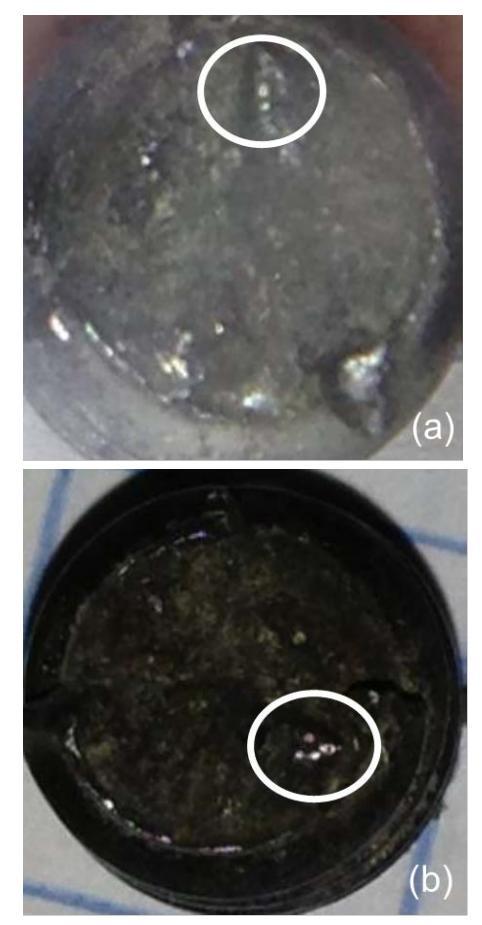
On the failure in propeller shaft was observed the relief on surface with granular shape in Figure 1(a) and (b), the thickness of material shown the characteristics on ductile material as plastic deformation or reduced diameter and texture, in the figure was possible identified the fracture initiation zone with sudden rupture led identify the zone to be analyzed using SEM.

Figure 1: Failure on surface zone.

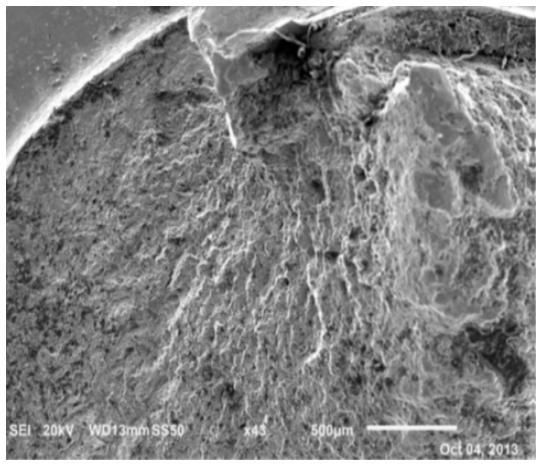
With Scanning Electronic Microscope was observed the propeller shaft of failure turbo compressor on thread root as reported M. Iphorski *et al. 2003* (Figure 2), they made failure analysis on rod vapor valve with failure located at the thread root. Iphorski identify that thread is a tensile concenter when there is high precipitation on grain borders and obviously is the fragile area.

Figure 2: Initialization failure (J. Ovejero García et al)

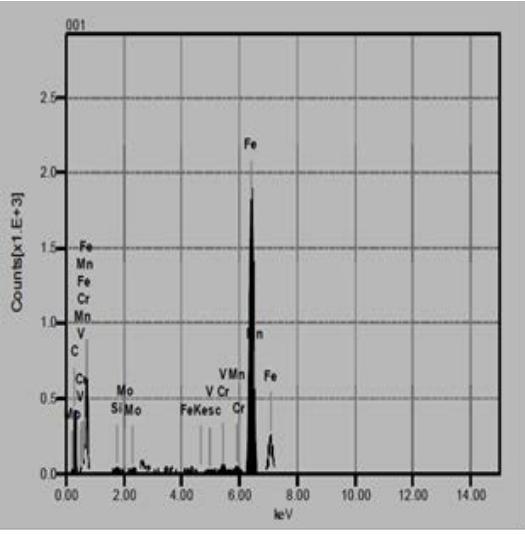
Figure 3: Elements detected in sample by EDS analysis.

With Energy Dispersive Spectroscopy were detected the elements V, Mn, Si, Mo, Fe and Cr in sample of propeller shaft as is showed in Figure 3.

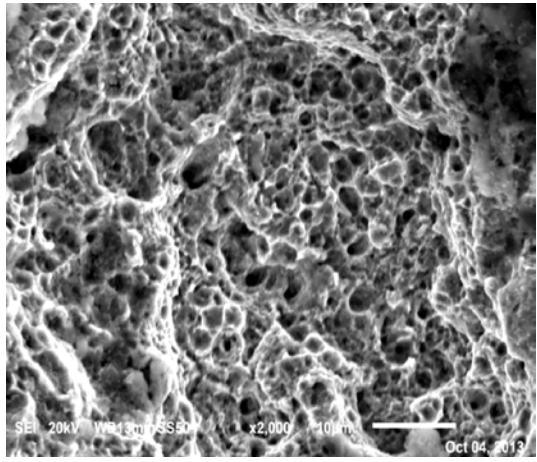
In Figure 4 is shown the SEM micrograph of the fractured material, was possible identify dimple rupture as usually appear on ductile materials, like an inter-granular fracture was observed so that fracture is typical in fiber zones, being possible use materials different to avoid this type of fracture.

Figure 4: Surface with dimple rupture.

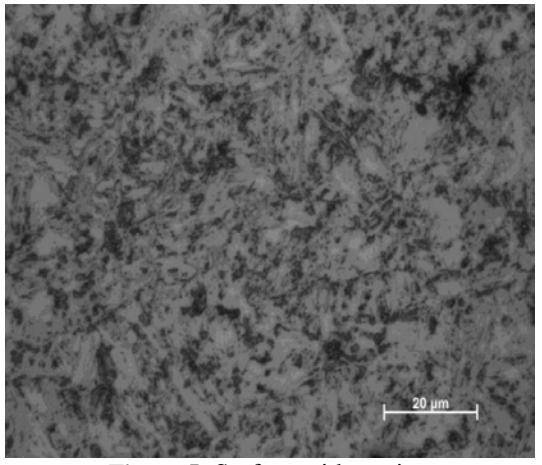
Respect to phases in material with metallography microscopy was determined with carbon, ferrite and perlite phases as is shown in Figure 5 and Figure 6, the phases are well defined, as is know the designers and companies avoid show specifications about of materials used, but with characterization techniques is possible compare the results to identify the material and generate possible recommendations in design to try to generate better results, so is possible compare the image of metallography with the phases identified on patrons of steel ANSI 1045. The hardness test let the evaluation of materials with the next values on HRC scale, the results indicate a similar ANSI 1045 steel (Principles of heat treatment of steel American Society of Metals), other situation was the maximum hardness detected in the center, it is a factor to generate the failure of material in the center of piece, as shown in Table 1.

Figure 5: Surface with tearing

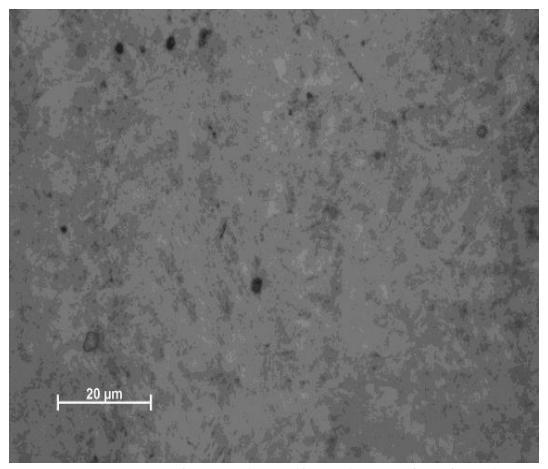
Figure 6: Ferrite and perlite phases in simple.

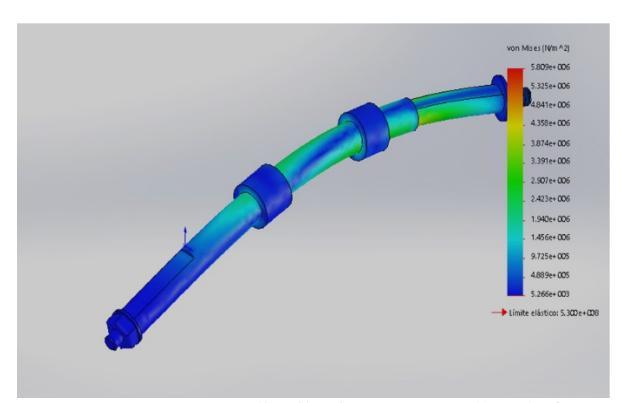
The analysis using CAD-CAE led analyzed the stress conditions on fragile section of propeller, it is only to compare possible areas, because the failure was not by stress, the analysis approximate to possible fracture toughness by simulation and try to understand the failure depending on loads, so were applied loads on the elements as is shown in Figure 7 on original conditions, on the figure 8 was possible identified sections to load an fix, so that on Figure 9 were showed the fixed elements to analysis, while on figure 10 are showed the values of loads on propeller, the moment correspond to motor. The results obtained on analysis in Figure 11 showed stress acceptable on mechanical resistance using steel ANSI 1045, the Von Misses stresses determined were under the values of resistance material, it is adequate with operational work, because the piece was working various years but is notable identify the spaces of stress concentrations on extreme, as can be observed in Figure 12, was possible identify concentration stress on thread root with this analysis, fibers observed, harness in the center and microvacancies facility the origin of fracture.

Figure 11: Stress distribution on propeller shaft

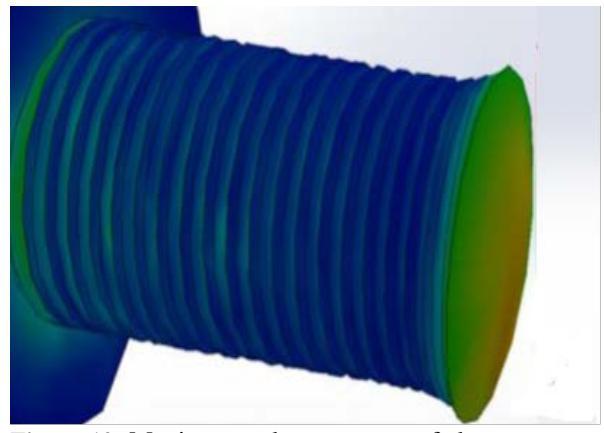
Figure 12: Maximum value on center of element stress.

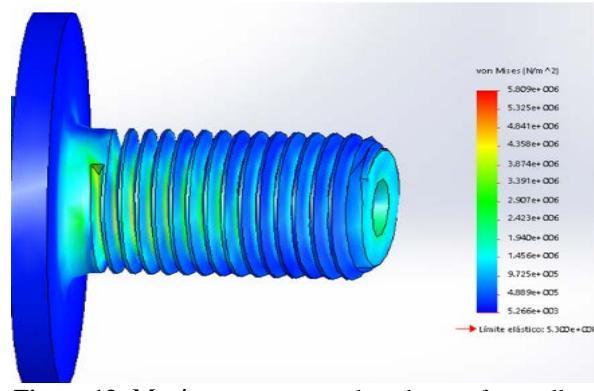
In Figure 13 is observed yellow colors localized on thread root of propeller, with a value of approximately of 4.538 MPa, it value is adequate on design, but the colors help to identify the fracture section, is close to real failure. The result confirms the identification of concentration stress, which was like failure in the propeller shaft part.

Figure 13: Maximum stress on thread root of propeller.

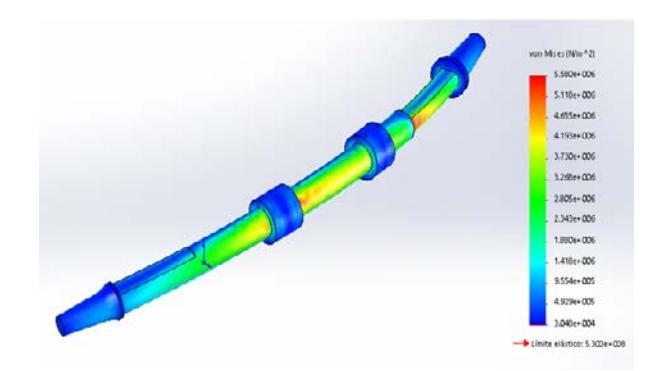
Figure 14: Maximum stress on propeller shaft.

In the design made by software CAD-CAE, was modified the geometry. In this case the linear thread was modified to a conical thread, The Figure 14 present the difference in tension with a lower value under the same conditions of experimental set up. In the Figure 15 is presented an enlarged view of the modified conical thread section, additionally are show the values of maximum stress on propeller shaft.

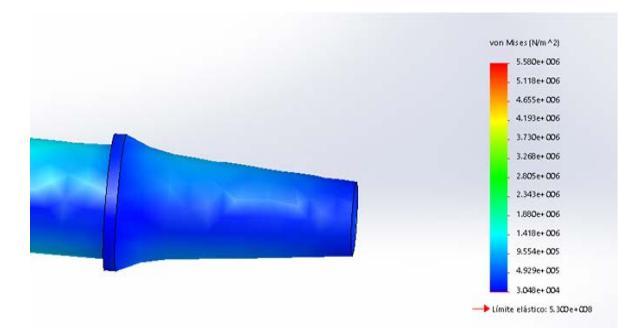
Figure 15: Maximum stress on modifies conical thread.

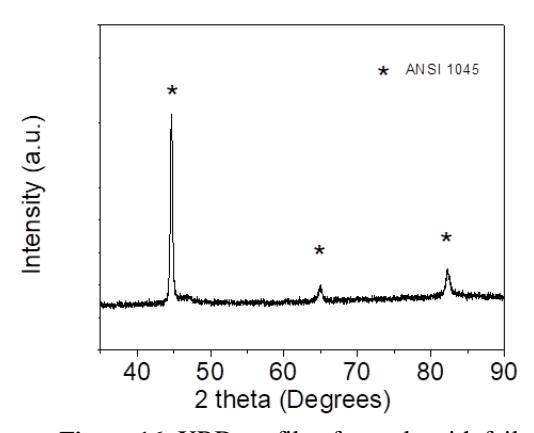
Finally, in XRD profile shown in Figure 16, obtained of propeller shaft sample, the peaks identified corresponding to a phase of ANSI 1045 steel like those reported by Eduardo da Rosa Vieira *et al.* 2021, all evidence allow identify the material close to ANSI 1045 which is considered for its properties and results from the simulation as the most appropriate material for support maximum stress on thread propeller.

Figure 16: XRD profile of sample with failure.
