Publicación anual, Vol. 8, No. 8 (2021) 25-29

Análisis de falla en propela de admisión en turbocargador de auto Failure analysis of propeller shaft in automotive turbocharger

M. Flores-Baez⁽¹⁰⁾, I. Flores-Baez⁽¹⁰⁾, P. Vera-Serna⁽¹⁰⁾*, R. Palomino-Resendiz⁽¹⁰⁾

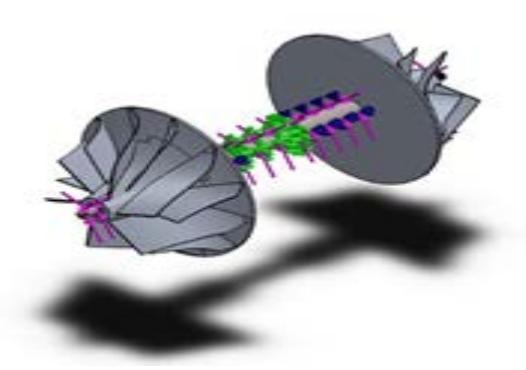
Figure 7: Original geometric conditions.

The analysis using CAD-CAE led analyzed the stress conditions on fragile section of propeller, it is only to compare possible areas, because the failure was not by stress, the analysis approximate to possible fracture toughness by simulation and try to understand the failure depending on loads, so were applied loads on the elements as is shown in Figure 7 on original conditions, on the figure 8 was possible identified sections to load an fix, so that on Figure 9 were showed the fixed elements to analysis, while on figure 10 are showed the values of loads on propeller, the moment correspond to motor. The results obtained on analysis in Figure 11 showed stress acceptable on mechanical resistance using steel ANSI 1045, the Von Misses stresses determined were under the values of resistance material, it is adequate with operational work, because the piece was working various years but is notable identify the spaces of stress concentrations on extreme, as can be observed in Figure 12, was possible identify concentration stress on thread root with this analysis, fibers observed, harness in the center and microvacancies facility the origin of fracture.
